**Plumbing & Leak detection**

**Leak Detection Report**

<b>Date:</b>	04/02/2023		
<b>Client:</b>	Leak Detection 3		
<b>Number:</b>	021 200 5887		
<b>Email:</b>	<a href="mailto:info@core-services.co.za">info@core-services.co.za</a>		
<b>Address:</b>	12345 Main Road Somerset West		
<b>Technician:</b>	John Smith + Peter Plumb		
<b>Start Time:</b>	11:30	<b>End Time:</b>	13:00
<input checked="" type="checkbox"/> Residential	<input type="checkbox"/> Pool	<input type="checkbox"/> Commercial	<input type="checkbox"/> Other

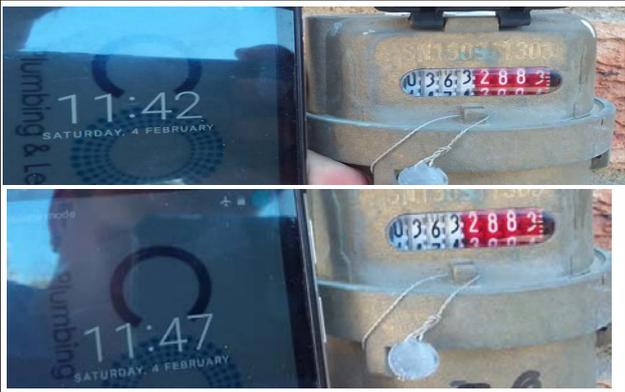
<p>Water meter inspection, No movement from:</p> <p><b>Time Start:</b> 11:42      <b>Time End:</b> 11:47</p> <p><b>Read Start:</b> 03632883      <b>Read End:</b> 03632883</p> <p>No movement noted on water meter when all points were closed.</p>

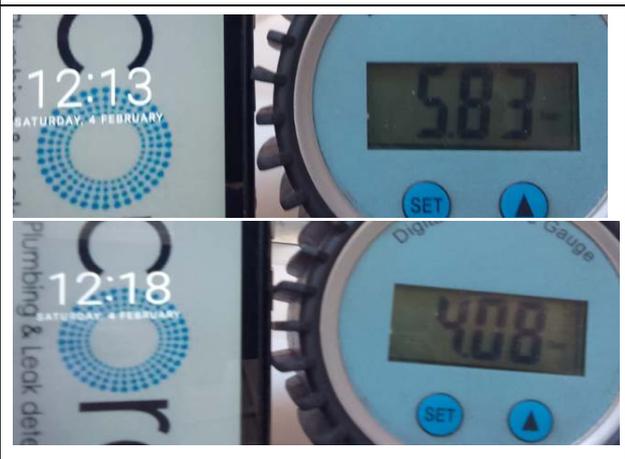
At the time of the inspection we conducted a visual inspection of the water meter and no movement was noted when all points were closed. We conducted a tracer gas pressure test on the main water supply line and a drop in pressure was noted. We conducted a tracer gas detection sweep on the unit and no tracer gas was detected. We conducted a flood and dye test on the shower adjacent to the affected area and dye and waterloss was noted in areas where grout has deteriorated and sealant was frail. We could not conduct a shower mixer to rose pressure test due to shower spout and rose being frail and we did not want to run the risk of breaking either component. We conducted thermal imagery on the shower walls after running hot water for a time period and thermal offshute was recorded around the shower mixer which could explain the drop in pressure during the pressure test conducted on the main water supply line.

<p>Pressure test conducted, drop in pressure from:</p> <p><b>Time Start:</b> 12:13      <b>Time End:</b> 5,83 Bar</p> <p><b>Read Start:</b> 12:18      <b>Read End:</b> 4,08 Bar</p> <p>Drop in pressure noted during pressure test conducted on main water supply line.</p>

- 1) We recommend that the area around the shower mixer be opened up in order to visually identify the leak and to repair.
- 2) We recommend that the shower base be stripped in order to reinstate the shower waterproofing before reinstalling the tiles

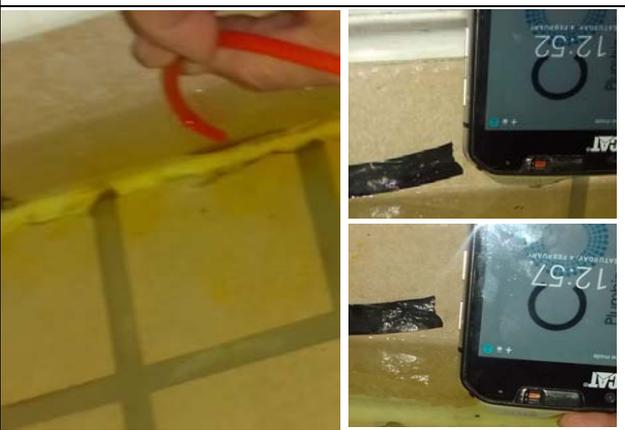
<p>Flood and dye tests conducted on shower base and both water and dye loss were recorded</p>

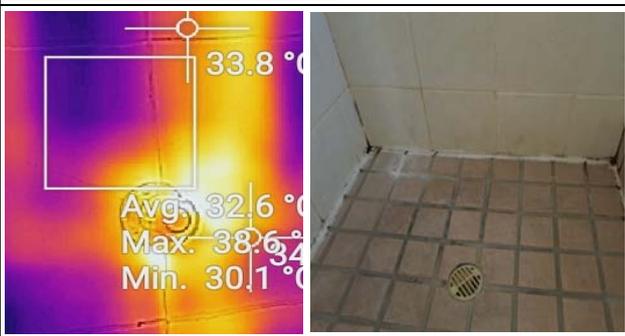
<p>Thermal offshute recorded with FLIR around shower hot water supply.</p> <p>Overall state of shower base in poor condition, with missing grout and frail and delaminated sealant.</p>
