Leak Detection Report

Date:	19/01/2023		
Client:	Leak Detection 5		
Number:	021 200 5887		
Email:	info@core-services.co.za		
Address:	12345 Main Road Fresnaye Cape Town		
Technician:	John Smith + Peter Plumb		
Start Time:	14:30	End Time:	15:45
<input checked="" type="checkbox"/> Residential	<input type="checkbox"/> Pool	<input type="checkbox"/> Commercial	<input type="checkbox"/> Other

Leak detection requested due to visible water damage on the ground floor ceiling, directly below a first floor bathroom shower. Client suspects that the leak is from an extension that was done on the shower rose.

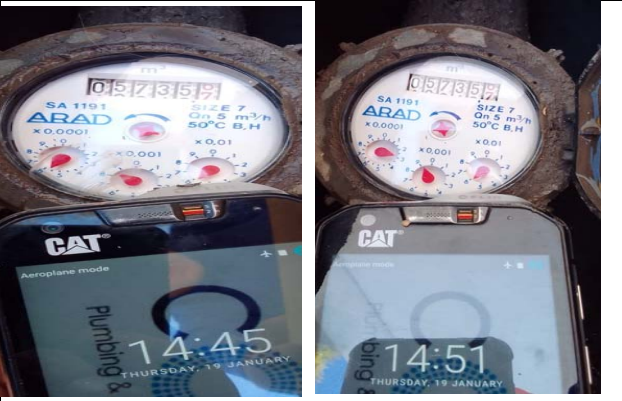
<p>Water meter inspection, movement from:</p> <p>Time Start: 14:45 Time End: 14:51 Read Start: 37357686 Read End: 37357693</p> <p>Movement noted on water meter when all points were closed. Suspected to be caused by visual leak identified at water meter.</p>

We recommend that the client alert the council in order to repair the leak on the water meter or replace.

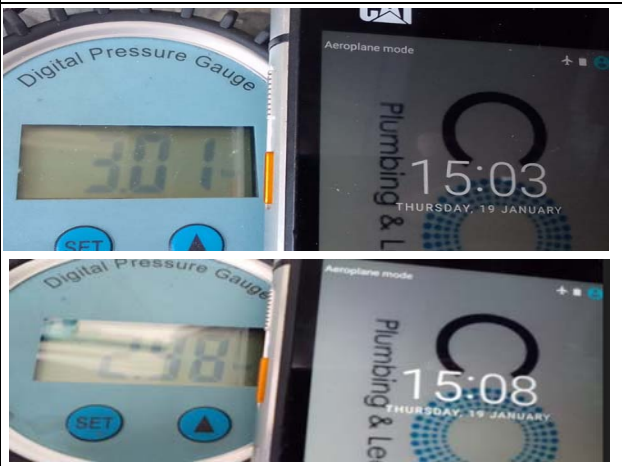
<p>Pressure test conducted, drop in pressure from:</p> <p>Time Start: 15:03 Time End: 15:08 Read Start: 3,01 Bar Read End: 2,98 Bar</p> <p>Insignificant drop in pressure noted during tracer gas pressure test on the main water supply line. Suspected to be caused by the leak at the water meter.</p>

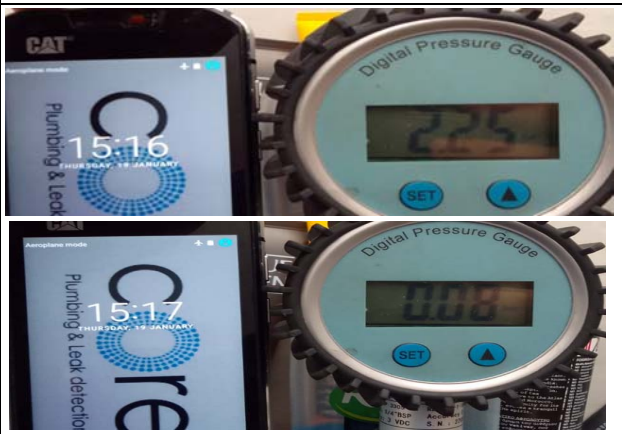
<p>Pressure test conducted, drop in pressure from:</p> <p>Time Start: 15:03 Time End: 15:08 Read Start: 3,01 Bar Read End: 2,98 Bar</p> <p>Significant drop in pressure noted during pressure test conducted on the shower mixer to rose line above the affected area.</p>

We recommend that the area where the thermal offshoot was identified be opened up and the leak be visually identified and repaired.

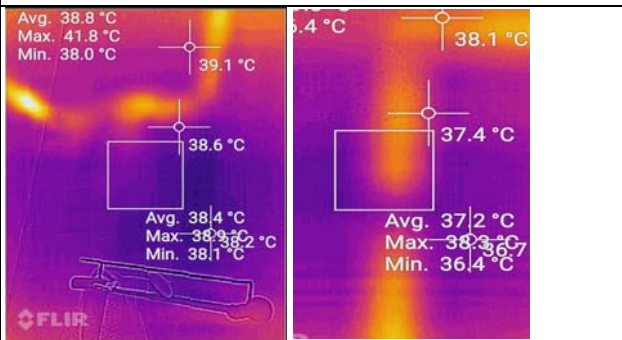
<p>Visual of thermal offshoot identified on the shower mixer to rose supply line.</p>
