Plumbing & Leak detection

Leak Detection Report

Date:	21/02/2023		
Client:	Pool Leak Detection 3		
Number:	021 200 5887		
Email:	info@core-services.co.za		
Address:	12345 Main Road		
	Bishops Court		
	Cape Town		
Technician:	John Smith + Peter Plumb		
Start Time:	10:00	End Time:	11:20
<input type="checkbox"/> Residential	<input checked="" type="checkbox"/> Pool	<input type="checkbox"/> Commercial	<input type="checkbox"/> Other

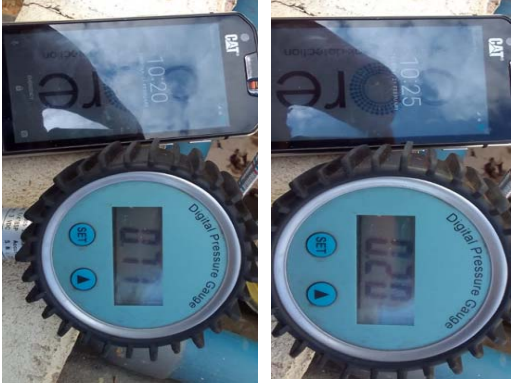
At the time of our inspection we conducted a tracer gas pressure test on the pool skimmer line and a drop in pressure was noted. We conducted a tracer gas detection sweep between the pump and the skimmer box and tracer gas was detected. We conducted an acoustic test in the area and a positive change in frequency confirmed the leak location to this position. We conducted a tracer gas pressure test on the pool jet line and no drop in pressure was noted. We could not conduct conclusive dye tests on any of the pool features due to pool being green.

<p>Pressure test conducted, drop in pressure from: Time Start: 10:20 Time End: 10:25 Read Start: 0.77 Bar Read End: 0.20 Bar Pressure test conducted on pool skimmer line drop in pressure noted.</p>

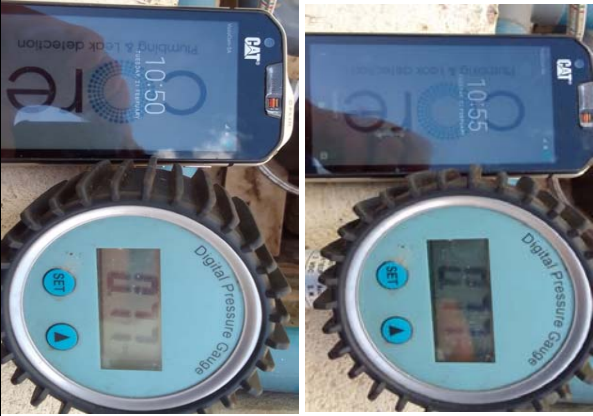
<p>Pressure test conducted, no drop in pressure from: Time Start: 10:50 Time End: 10:55 Read Start: 0.77 Bar Read End: 0.77 Bar No drop in pressure noted during pressure test conducted on the pool jet line</p>

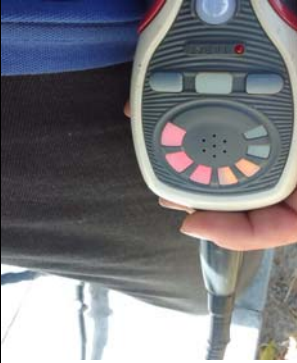
<p>Visual of tracer gas detected between the pool skimmer box and the pump</p>

We recommend that the area where the tracer gas was identified be opened up order to visually identify and repair the leak. We recommend that the pool level be monitored and possibly have dye tests performed once the water is clear, should the water loss persist.

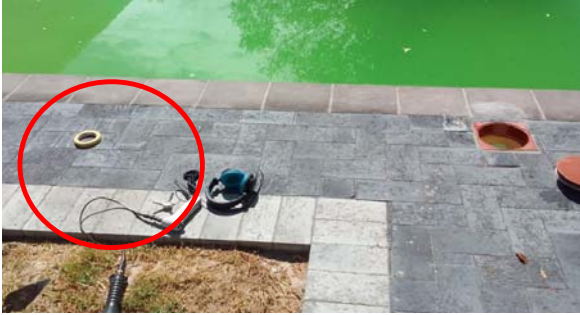
<p>Area where leak is suspected to be located.</p>
