Leak Detection Report

Date:	22/02/2023		
Client:	Pool Leak Detection 2		
Number:	021 200 5887		
Email:	info@core-services.co.za		
Address:	12345 Main Road		
	Durbanville		
	Cape Town		
Technician:	John Smith + Peter Plumb		
Start Time:	13:00		
End Time:	14:00		
<input type="checkbox"/> Residential	<input checked="" type="checkbox"/> Pool	<input type="checkbox"/> Commercial	<input type="checkbox"/> Other

Leak detection requested due to pool losing water.

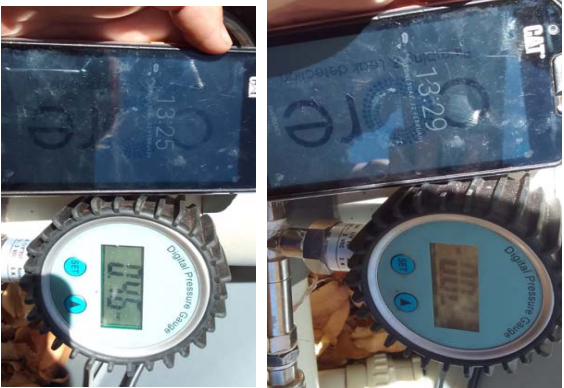
<p>Pressure test conducted, drop in pressure from:</p> <p>Time Start: 13:25 Time End: 13:29</p> <p>Read Start: 0.46 Bar Read End: 0.02 Bar</p> <p>Significant drop in pressure noted during pressure test conducted on pool skimmer line.</p>

We recommend that the area directly behind the pool skimmer box be opened up in order to visually identify the leak and to repair.

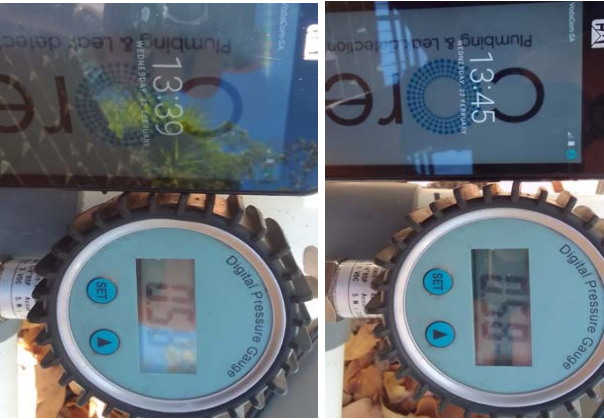
<p>Pressure test conducted, no drop in pressure from:</p> <p>Time Start: 13:39 Time End: 13:45</p> <p>Read Start: 0.58 Bar Read End: 0.58 Bar</p> <p>No drop in pressure noted during pressure test conducted on pool jet line.</p>

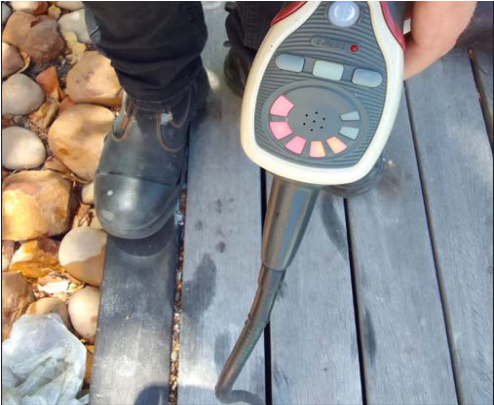
At the time of our inspection we conducted a tracer gas pressure test on the pool Jet line and no drop in pressure was noted. We conducted a tracer gas pressure test on the pool skimmer line and the line could not build pressure higher than 0.46 Bar and indicated significant pressure loss. We conducted a tracer gas detection sweep around the pool and tracer gas was detected directly behind the pool skimmer box. We also conducted dye tests on all pool accessories and no dye loss was noted.

<p>Visual of tracer gas detected behind skimmer box</p>

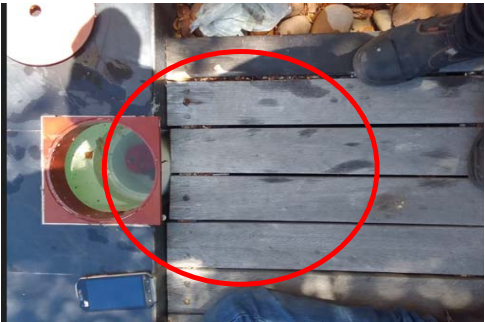
<p>Area where leak is located.</p>
